**Urgent Medical Device Field Correction/Removal - Immediate Action
Required**

**Auriga™ 30 and Auriga™ XL 4007
Laser System**

10 April 2019

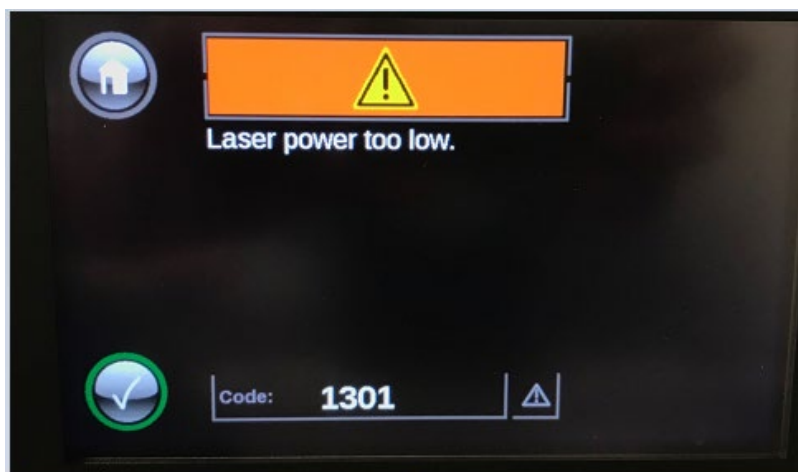
Figure 1: 1301 Low Power Error

The Auriga consoles in **Table 1** may exhibit faster than normal power degradation due to a potential issue with the mechanical cooling system that could lead to a low power error (1301) to be displayed on the screen as illustrated in **Figure 1**. The console is designed to stop emitting laser pulses and enters a stand-by mode after a low power error message. If this occurs, please follow the recommendations below. The most common outcome anticipated to occur is no health consequence to the patient. The worst case reported harm is a short delay of the procedure while other power settings are selected.

1. If the 1301 low power error is displayed on the screen, per the Auriga user manual, confirm the message before continuing the procedure.
2. Using the green and blue arrows in the display, select a combination of power settings for Energy (mJ) and Frequency (Hz) that will enable you to successfully complete the procedure. This can be done by altering the frequency settings or energy settings by one or two increments to achieve required power, as outlined within the Auriga User Manual.
3. In the event that there is no combination of power settings adequate to complete the case, please discontinue use of the console and contact Boston Scientific as detailed below.
