Urgent: Medical Device Correction

Update to September 2016 Field Action:

Important information regarding the Medtronic Model 37751 Recharger

28 February 2019

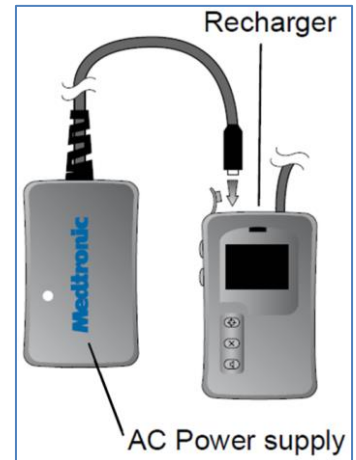
Figure 1

In 2016, Medtronic identified an increased number of complaints from customers involving reports of Rechargers that are in an unresponsive error state, where the Recharger is non-functional with a blank display screen and is beeping every 5 seconds. Medtronic determined that Rechargers manufactured

When this error state occurs, the Recharger is unable to recharge the neurostimulator until the Recharger is reset. If the neurostimulator battery is allowed to become fully depleted, this can lead to loss of therapy and return of associated disease-specific symptoms. If the implanted neurostimulator battery is allowed to remain fully depleted, it may overdischarge, resulting in a permanent reduction in battery capacity and the need to recharge more frequently in the future and/or replace the implanted device.

- To prevent this unresponsive error state, the Recharger should be plugged into the AC power supply (by aligning white triangles) prior to starting a recharging session of the neurostimulator and remain connected to the AC power supply until the recharging session has finished (see Figure 1). Note: The AC power supply does not need to be plugged into a power outlet if the Recharger is charged.
