SIEMENS SOMATOM Emotion(2007)
SIEMENS SOMATOM Spirit/Power
SIEMENS SOMATOM Scope/Power
SIEMENS SOMATOM Perspective

Customer Safety Advisory Notice CT076/17/S

Re: CARE Dose4D algorithm – Risk of unnecessary radiation exposure for head scans based on p.a./a.p. topograms

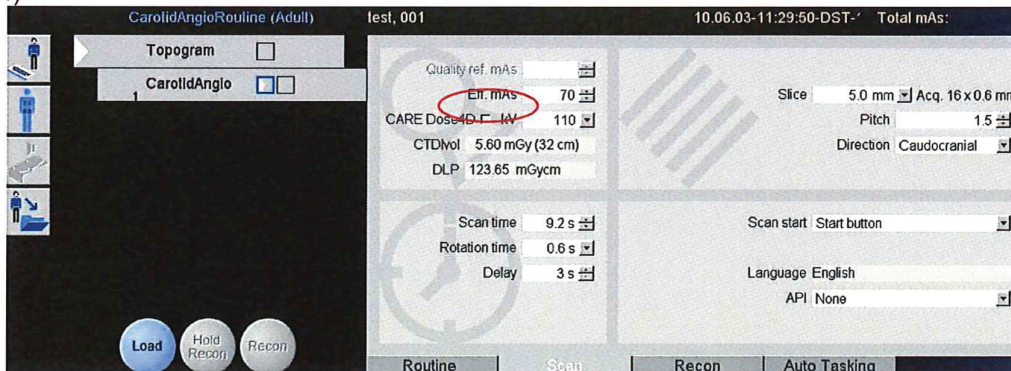
Siemens Healthcare became aware of possible incorrect tube current calculations by the CARE Dose4D algorithm for head scans based on p.a. (posterior-anterior) or a.p. topograms. Depending on the geometrical shape of the skull bone, it may happen in rare cases that the calculated dose distribution is not appropriate and could lead to unnecessary radiation exposure.

Fig.1 deactivate the check box for CARE Dose4D

Considering that the p.a. or a.p. topogram is preferred in specific protocols such as in CarotidAngio scans and RT_HeadNeckShoulder, we strongly recommend to deactivate the CARE Dose4D function for this type of scan(Fig.1)

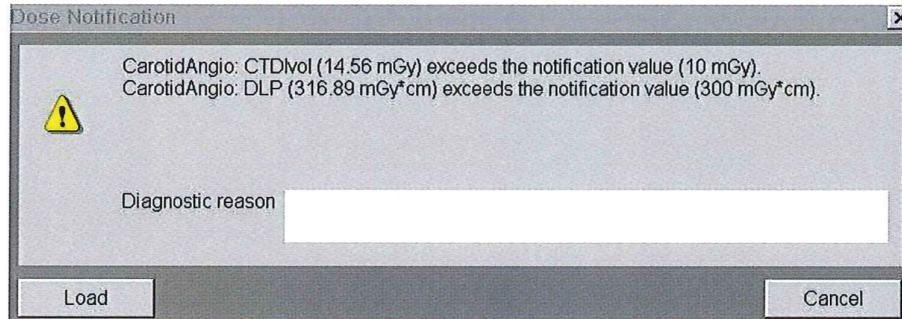
Furthermore, the user can configure dose notification thresholds for every scan range (please refer to the "Instructions for Use" or "Operator Manual"). If a dose notification threshold is configured and is bound to be exceeded, a notification requesting a confirmation by the user pops up prior to the scan (Fig. 2)

Fig. 2 Pop up window "Dose Notification" in case a configured threshold is exceeded
