SIEMENS SOMATOM go.Up
SIEMENS SOMATOM go.Now

Safety Advisory Notice CT013/18/S

Re: SOMATOM go.Up and SOMATOM go.Now – Risk: Patient rescan might become necessary

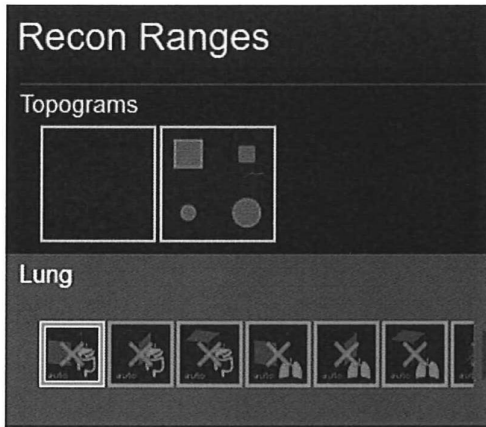
Topic 1: We have observed sporadic software stability problems preventing the start of a reconstruction after the CT examination. If these problems occur, this is indicated by a red cross in the "Job Status" table (see example in Fig. 1 on page 2).

[Fig. 1]
Screenshot example "Job status" – no reconstruction possible

Topic 1: If a reconstruction cannot be started after an examination, please reboot the system and repeat the aborted reconstruction. If the error persists, please contact your local Siemens Healthineers service support team. They can help you to decide whether a rescan is necessary or not.

The stability and image quality issues mentioned are solved by the software updates VA10A_SP2 and VA20A. The Osteo reconstruction issue is solved with the VA20A software update. The respective upgrade of your system is scheduled for the second half of this year 2018. You will be informed as soon as the update(s) are available for your system.

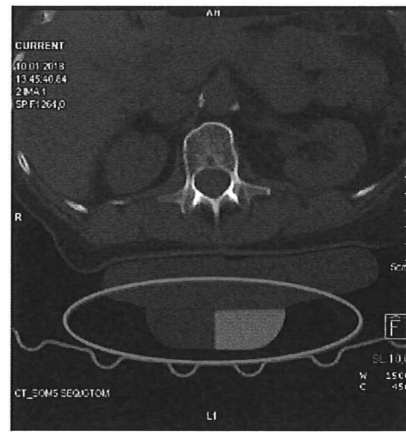
A successful and complete Osteo reconstruction is visualized by full green bars in the column "Recon Progress" of the "Job Status" table and by images including the Osteo phantom in the tab card "CT View&Go" (for details please see Fig. 3 below). An example of a correct Osteo reconstruction is provided in Fig. 2. After checking the successful and complete Osteo reconstruction you may close the scan/recon tab card.

[Fig. 2]
Example of a successful reconstruction for later use in syngo Osteo CT

Topic 3: After an osteoporosis scan has been completed, the Osteo reconstruction needs to be started and completed directly after the scan. Therefore the images should be loaded and checked in "CT View&Go" – before the scan/recon tab card is closed. Please do not close the scan/recon tab card before you have reconstructed and checked all Osteo images.

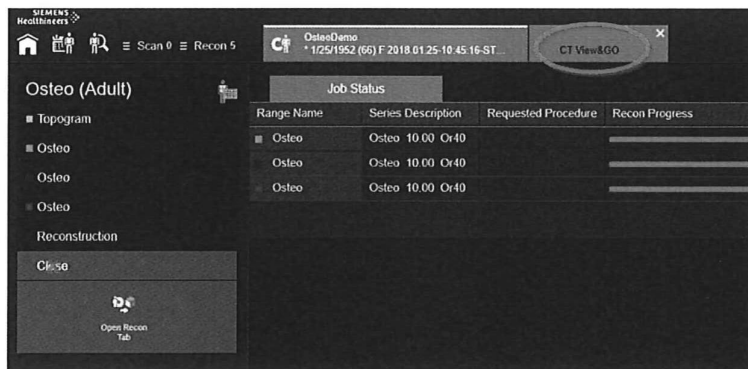
[Fig. 3]
GUI screenshot with Recon Progress bar
