## Customer Safety Advisory Notice CAN 001-2018

**Re:** CARE Dose4D algorithm – Risk of unnecessary radiation exposure in CT scans that include the head, based on PA/AP topograms

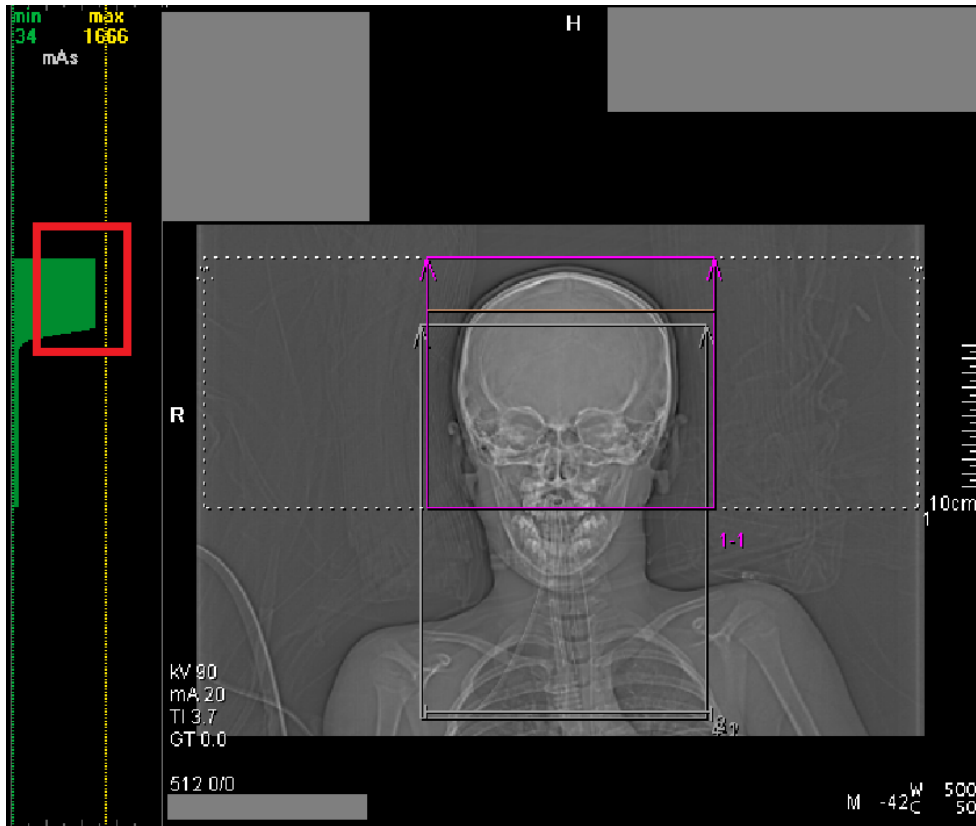
Figure 1. Topogram with calculated mAs profile

For customers that have a Biograph mCT or Biograph mCT Flow, the calculated mAs profile (dose profile) of the planned scan range displays on the left side of the screen after the topogram completes (Figure 1).

Any unusual dose distribution, similar to the graph reflected in Figure 1, indicates a possible miscalculation of the CARE Dose4D algorithm. You can easily recognize the very sudden and strong increase of the tube current in the upper part of the skull (Figure 1, red rectangle). In the event you become aware of the described behavior, do not start the scan, run a new lateral topogram, and check the dose distribution again.

The described issue does not occur when using a lateral topogram. Accordingly, we strongly recommend the utilization of topograms in the lateral position for all CT and PET/CT scans that include the entire head. Alternatively, if you choose to perform both a lateral topogram in conjunction with a PA or AP topogram you must ensure that you perform the lateral topogram last as CARE Dose4D is based on the last topogram. If you do not utilize a lateral topogram for scans including the entire head, we strongly recommend that you deactivate the CARE Dose4D feature.

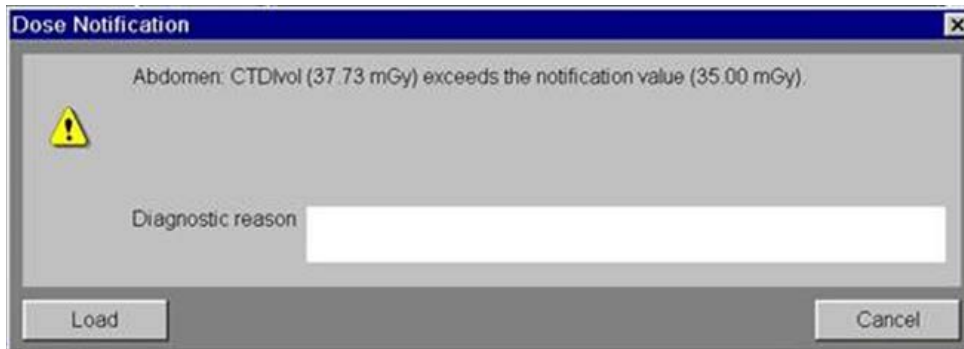
Figure 2. Pop-up window "Dose Notification" in case a configured threshold is exceeded

Furthermore, you can configure dose notification thresholds for every scan range (please refer to your Biograph Operators Manual for your corresponding software version). If a dose notification threshold is configured and is bound to be exceeded, a notification requesting a confirmation pops up prior to the scan (Figure 2).
