**Customer Information Letter  
Medical Device Correction  
860306 Philips PageWriter TC30 Cardiograph**

**Blank I/O Module**

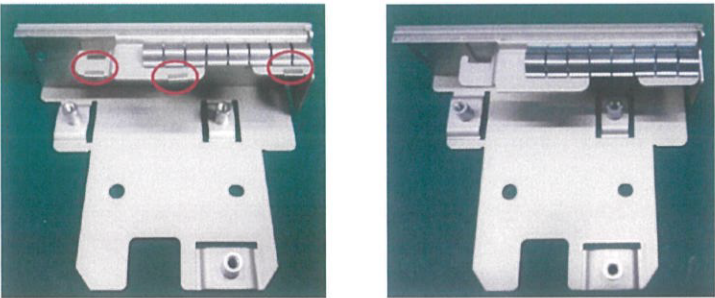
<b>AFFECTED PRODUCTS</b>	The affected products are the 860306, Philips PageWriter TC30 cardiographs, with serial numbers: [REDACTED]
<b>PROBLEM DESCRIPTION</b>	<p>A manufacturing assembly problem has been detected on the 860306 Philips TC30 Cardiograph, where three additional non-functional ground springs on the Blank I/O module could become loose potentially leading to an internal short that could cause the cardiograph to stop working.</p> <div data-bbox="592 595 1310 925"> <div data-bbox="687 595 823 613">Incorrect Assembly</div> <div data-bbox="1078 595 1203 613">Correct Assembly</div>

<b>ADVICE ON ACTIONS BY CUSTOMER / USER</b>	Upon receipt of this notification, promptly locate your affected device.
<b>ACTIONS PLANNED BY PHILIPS</b>	Philips has issued a correction, free of charge. You will be contacted by a Philips representative to schedule an appointment to perform the removal of the additional non-functional ground springs from your Philips TC30 Cardiograph.
<b>FURTHER INFORMATION AND SUPPORT</b>	If you need any further information or support concerning this issue, please contact your local Philips representative: <Healthcare Representative/Modality Engineer: 1800-744-5477 or (Overseas Number)>
