URGENT FIELD SAFETY NOTICE - SINGAPORE

Commercial Name: Convex Two-Piece Skin Barriers i.e. Natura / Surfit / Combihesive Wafers
(see Appendix A for commercial name and full details)

FSCA Ref.: 2019-006MA

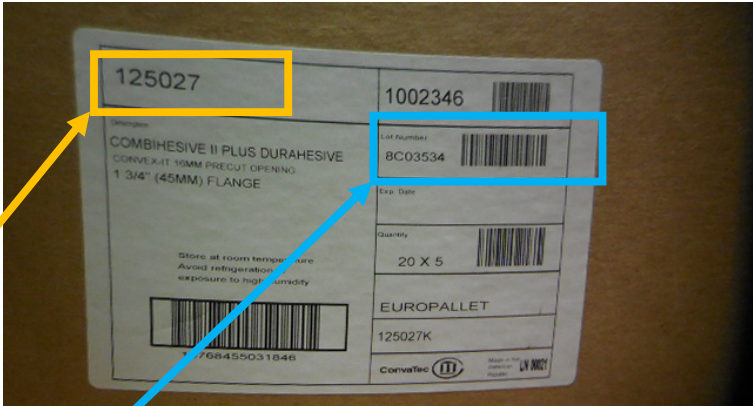
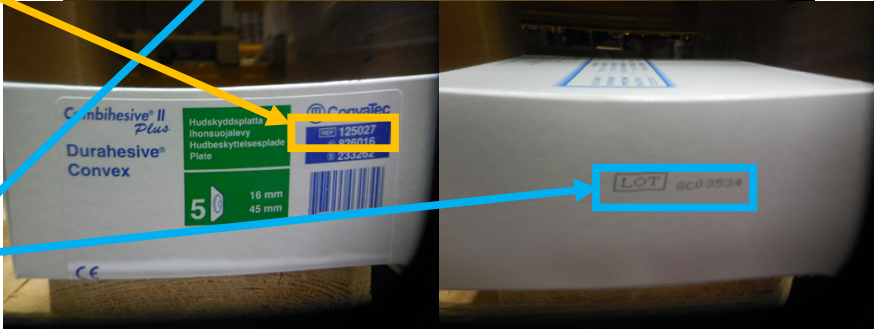
For the AFFECTED product	
<p>...the shipper and market unit labeling will include the product code and lot number.</p> <p>See example photos to the right.</p> <p>Product Code (REF/SKU)</p> <p>Lot Number</p>

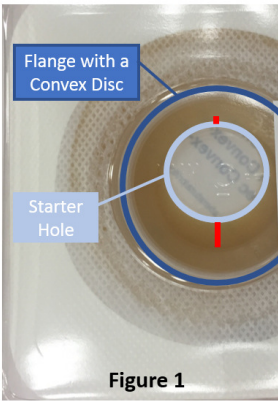
<p>Figure 1</p> </div> <div> <p>Centered Starter Hole (Stoma Hole) This product should be within specification</p>

<p>... the physical product will present as a skin barrier with a starter hole (stoma hole), as shown to the right.</p>	<div> <p>Off Center Starter Hole (Stoma Hole) This product may be out of specification</p>

<p>Figure 2</p> </div> <div> <p>The starter hole should be "centered" in relation to the flange.</p> <p>The red lines in the photo on the left should be more equal.</p> <p>The green lines in the photo on the right are more equal.</p> </div>

3	<p>If you have any product you have identified as off-centre in your possession, please contact the FSCA Help Desk.</p> <p>ConvaTec will accept product returns and replace product free of charge. You do not need to open or inspect this product.</p>
4	<p>Action: Please complete the Field Safety Notice End User Response Form and return to the FSCA Help Desk by fax or email as soon as possible. Include details of product to be returned, if applicable. This information is required to allow ConvaTec to perform effectiveness checks.</p> <p>Please contact the FSCA Help Desk if you have any additional questions.</p>

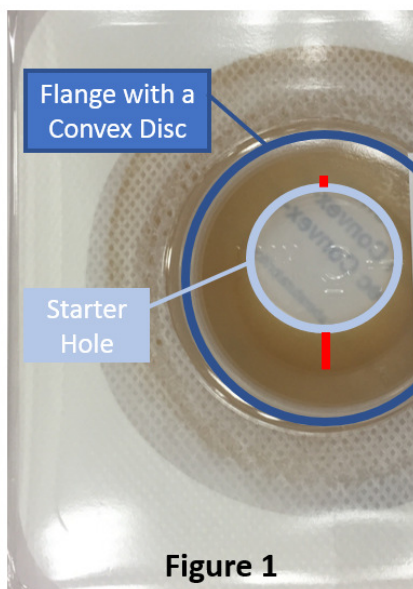
Off Center Starter Hole (Stoma Hole)
This product may be out of specification

The starter hole should be "centered" in relation to the flange.

The **red** lines in the photo on the left should be more equal.

- Please examine your inventory. If you have received product that resembles **Figure 1 on the left**, isolate the affected product and contact the ConvaTec Customer Service Team at one of the numbers below to arrange for return and replacement of the affected product.

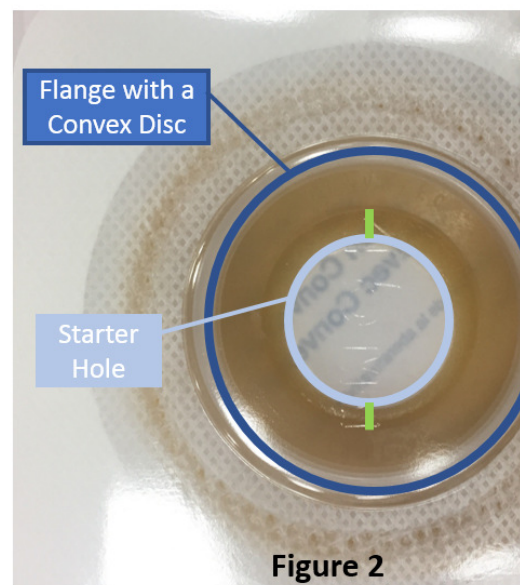
The **green** lines in the photo on the right are more equal.

Centered Starter Hole (Stoma Hole)
This product should be within specification

- If you have received product that resembles **Figure 2 on the right**, no additional action is needed.
- If you are unsure, please contact the ConvaTec Customer Service Team for assistance.
